# LAKE TRANQUILITY DAM

**NJ 00275**

## PHASE I INSPECTION REPORT NATIONAL DAM SAFETY PROGRAM

11 MARCH 1981

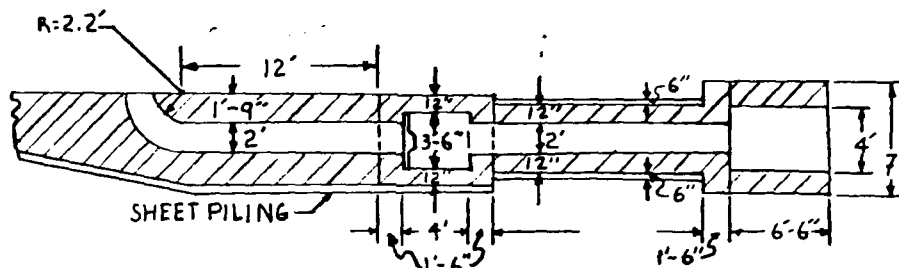
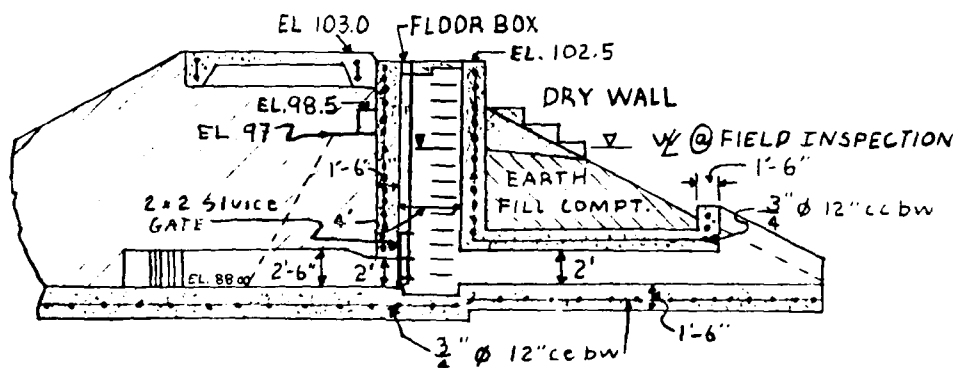
TRANQUILITY LAKE DAM (00275)		
SLUICE DETAILS		
GREEN TOWNSHIP, SUSSEX NEW JERSEY		
LANGAN ENGINEERING ASSOCIATES, INC.		
990 CLIFTON AVENUE CLIFTON, N.J. 07013		
DRN. BY: <i>Mark Todd</i>	SCALE: NTS-	JOB No. 80145
CK'D. BY:	DATE: 9-4-80	FIG. No. 2C

The present drawdown structure consists of a 2' x 2' square concrete sluice in the south spillway abutment (see Fig. 2c) with an invert elevation of 88.0. Its operating condition is unknown. Drawdown of the reservoir has been evaluated assuming that the drawdown structure is operable. Our calculations indicate that the lake level could be lowered 6 1/2 ft in approximately 3 days.
